NASA Technical Memorandum 4634
ATCOM Technical Report 95-A-001

Exploratory Flow Visualization Investigation of Mast-Mounted Sights in Presence of a Rotor

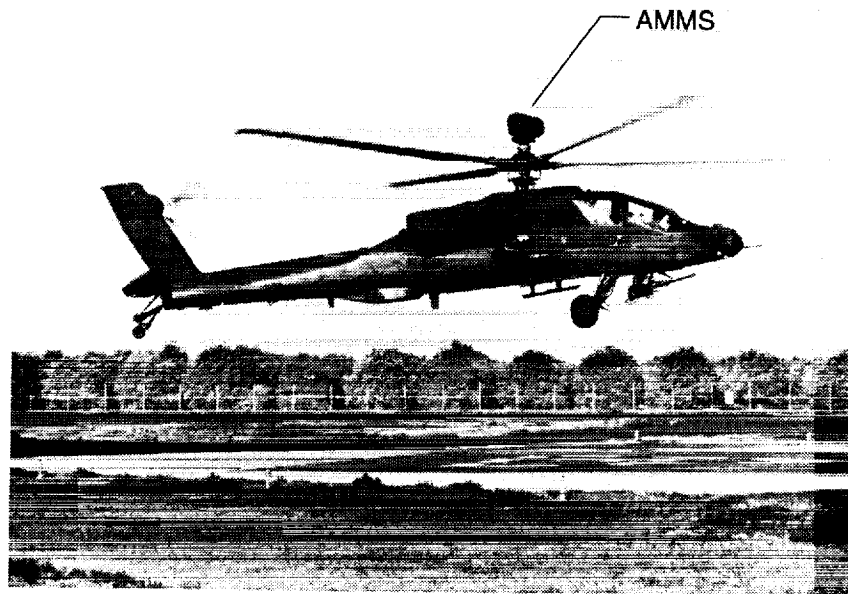
Figure 1. AH-64D Apache Longbow attack helicopter with asymmetric sight installed.

During recent industry development flight testing on an AH-64D Apache/Longbow attack helicopter equipped with an asymmetric mast-mounted sight (AMMS), severe vibration was encountered during certain rearward flight conditions. (See fig. 1.) Previous testing on the aircraft with a symmetric mast-mounted sight (SMMS) revealed no adverse vibration problem. The government and industry team conducting the flight tests proposed the following aerodynamic explanations of the adverse vibration:
